SEPA Environmental Checklist (WAC 197-11-960)

Kittitas County Transfer Station and Maintenance Facility Relocation Project

Version 4 March 2020 Kittitas County, Washington

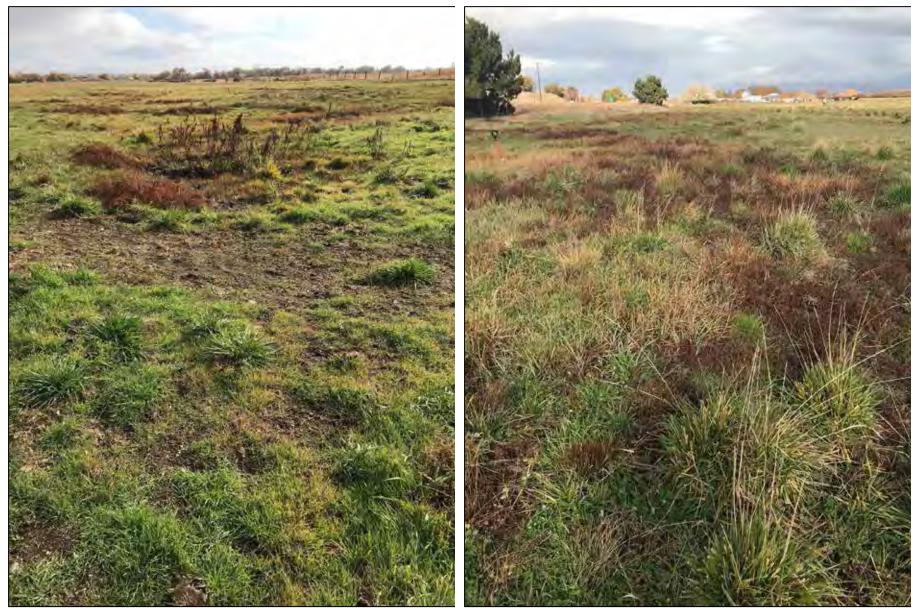
Photo 3 Wetland 1, view east from photo point WW1 PP3.

Photo 4 Wetland 2, view north from photo point WW2 PP1.

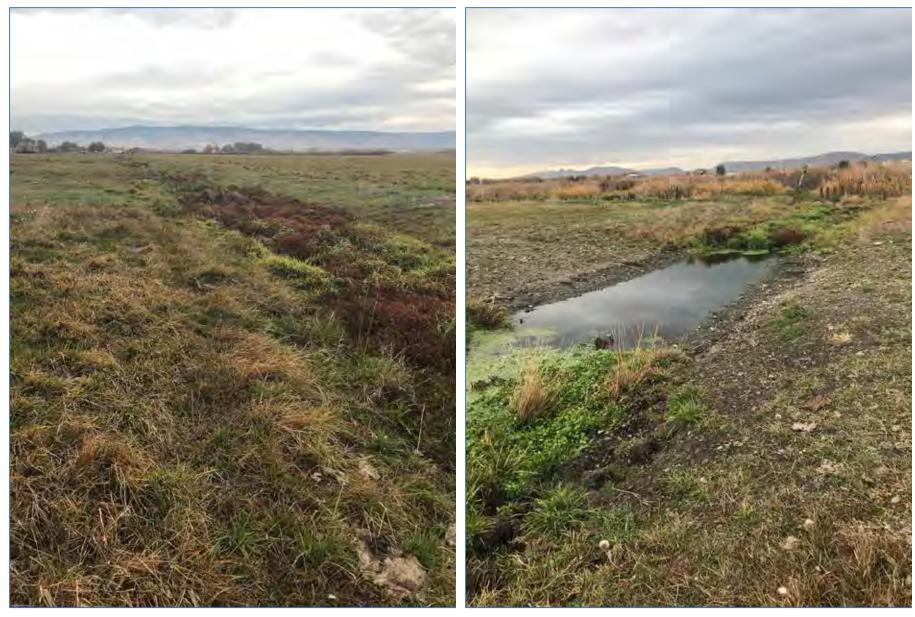
Photo 1 View north from Photo Point 1, ditch D1.

Photo 2 View south from Photo Point 1, ditch D1.
